Vehicle Detail Report

Jetour Freedom 2025 1.5TD Discover

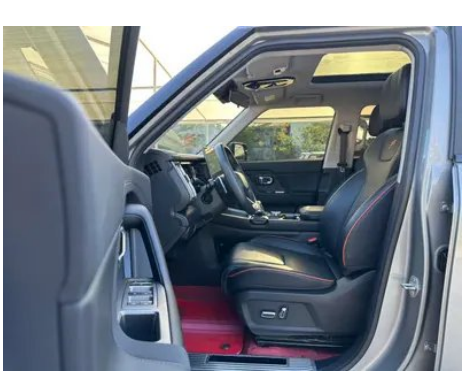
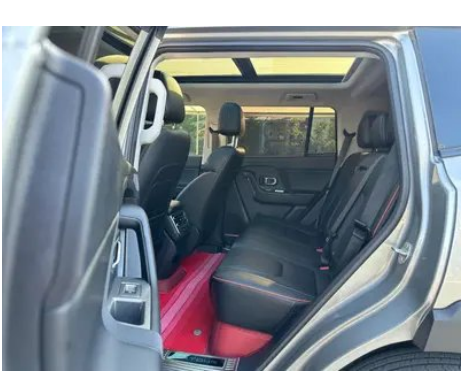
1. Driver’s seat slide rail, Driver's seat rails and frame, Signs of removal. 2. Passenger seat track, Front passenger seat rails and frame, Signs of removal. 3. Left front door, Paint chip, Scratch. 4. Left rear door, Paint chip, Deformation. 5. Right rear door, Scratch. 6. Left front fender, Scratch. 7. Right front fender, Deformation, Scratch damage. 8. Windshield, Stone chip.
