Vehicle Detail Report

Jetour X70L 2026 2.0TD 8AT Flagship

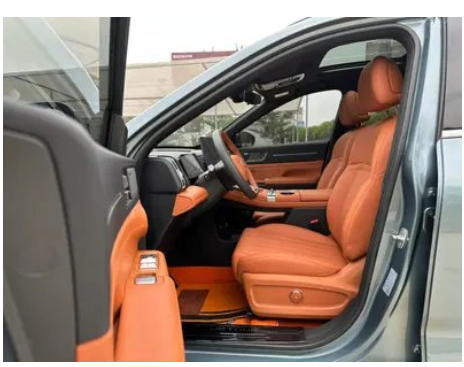
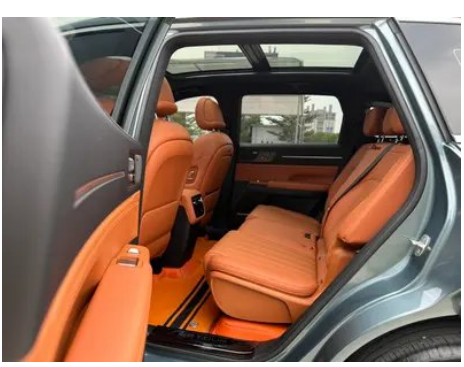
1. Right roof side member, Right upper side rail, Scratch. 2. Driver’s seat slide rail, Driver's seat rails and frame, Signs of removal. 3. Passenger seat track, Front passenger seat rails and frame, Signs of removal. 4. Hood, Hood, Paint chip. 5. Front bumper, Scratch damage. 6. Right front door, Scratch. 7. Right rear door, Paint chip, Scratch. 8. Trunk lid, Trunk lid, Scratch. 9. Left front fender, Scratch. 10. Left rear quarter panel, Scratch.
