Vehicle Detail Report

Honda Civic 2020 HATCHBACK 220TURBO CVT Tide Cool Control

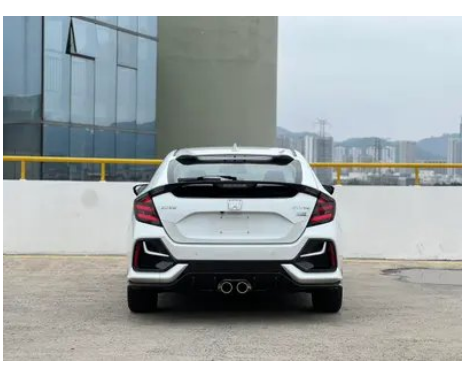
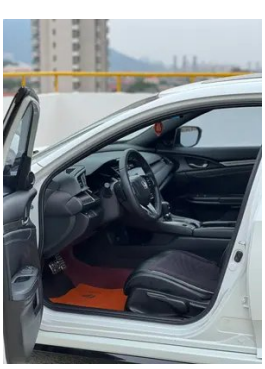
1. Right, B, Column Sealing, Inner side of right B-pillar, Non-accident-related deformation. 2. Driver’s seat slide rail, Driver's seat rails and frame, Signs of removal. 3. Passenger seat track, Front passenger seat rails and frame, Signs of removal. 4. Right rear quarter panel, Paint repair, Body panel repair. 5. Airbag, Signs of removal.
