Vehicle Detail Report

Honda Accord 2023 Sharp ·T move 260TURBO Smart Edition

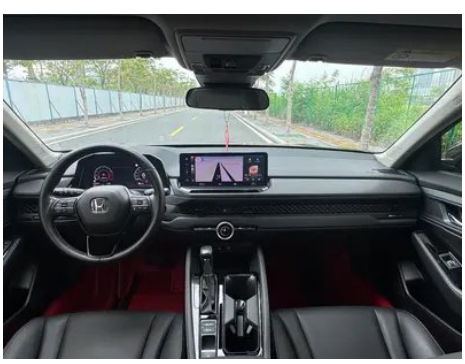
1. Right bottom edge beam, Right rocker panel, Scratch damage. 2. Driver’s seat slide rail, Driver's seat rails and frame, Signs of removal. 3. Passenger seat track, Front passenger seat rails and frame, Signs of removal. 4. Left rear quarter panel, Scrape, Deformation. 5. Right rear quarter panel, Deformation. 6. Body floor pan, Deformation.
