Vehicle Detail Report

Geely Preface 2020 2.0T Flagship

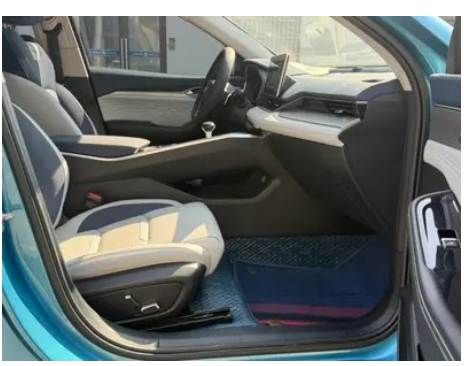
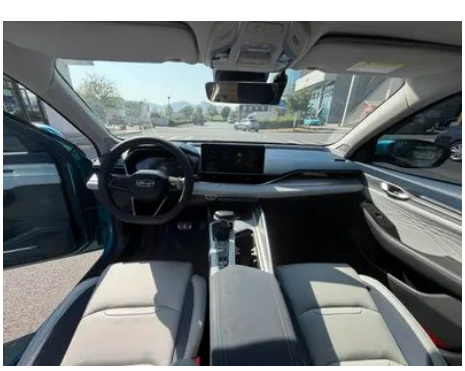
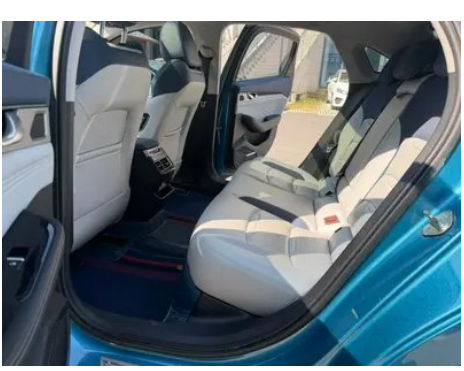
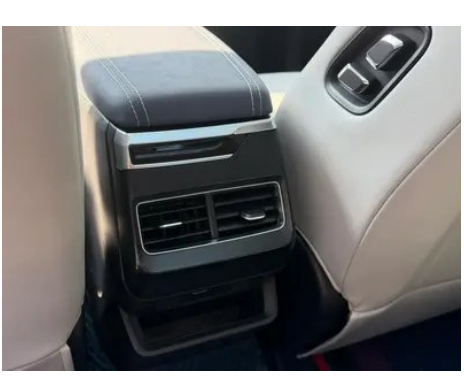
1. Radiator support, Signs of removal, Replaced. 2. Left rear frame rail, Deformation. 3. Left front fender lining, Left front fender structure, Deformation, Body panel repair. 4. Rear body panel, Deformation. 5. Driver’s seat slide rail, Driver's seat rails and frame, Signs of removal. 6. Left rear quarter panel, Paint repair, Body panel repair. 7. Right rear quarter panel, Paint repair.
