Vehicle Detail Report

Honda Elysion 2022 2.0L Hybrid Deluxe Edition

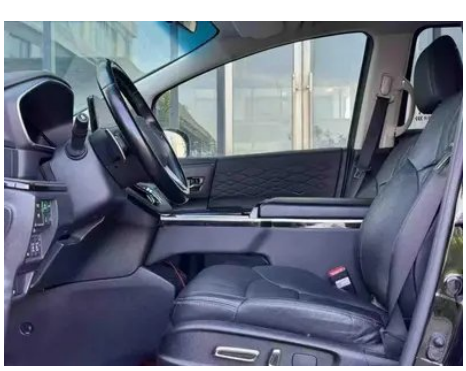
1. Left roof side member, Left upper side rail, Scratch. 2. Left bottom side member, Left rocker panel, Scratch damage. 3. Driver’s seat slide rail, Driver's seat rails and frame, Signs of removal. 4. Passenger seat track, Front passenger seat rails and frame, Signs of removal. 5. Front bumper, Paint repair. 6. Left rear door, Scratch. 7. Left rear wheel rim, Scrape. 8. Right rear wheel rim, Scrape. 9. Left front fender, Paint chip, Scratch damage, Deformation, Signs of removal, Paint repair, Body panel repair.
