Vehicle Detail Report

Toyota Levin 2023 Dual Power 1.8L Luxury Edition

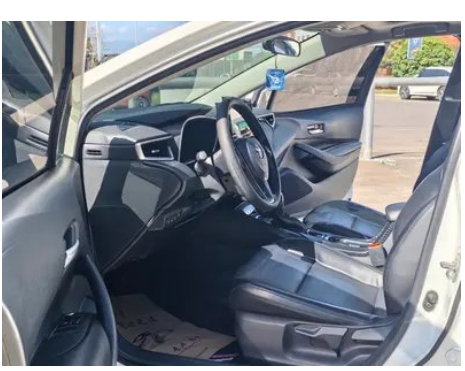
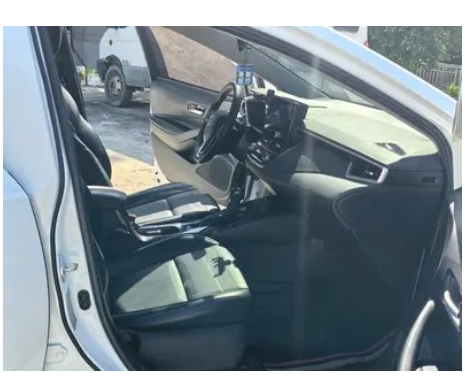
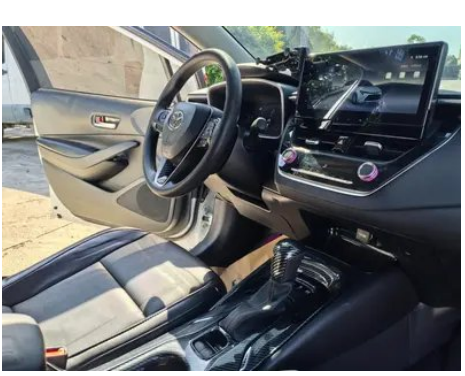
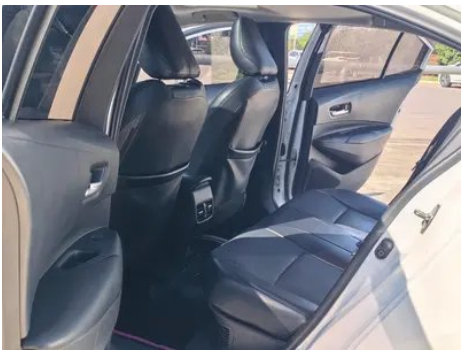
1. Firewall, Deformation. 2. Right roof side member, Right upper side rail, Deformation. 3. Right bottom edge beam, Right rocker panel, Outer-side deformation. 4. Driver’s seat slide rail, Driver's seat rails and frame, Signs of removal. 5. Passenger seat track, Front passenger seat rails and frame, Signs of removal. 6. Right rear quarter panel, Deformation. 7. Body floor pan, Deformation.
