# Vehicle Detail Report

## Kia Run 2015 1.6L Automatic Special

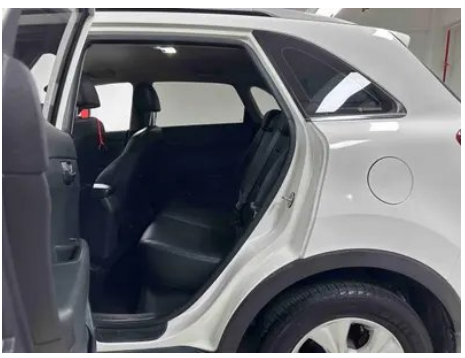
1. Left roof side rail: Left upper side rail, Paint repair, Body panel repair. 2. Right B-pillar edge: Inner side of right B-pillar, Non-accident-related deformation. 3. Driver's seat slide rails: Driver's seat rails and frame, Corrosion. 4. Left rear quarter panel: Paint repair. 5. Right rear quarter panel: Paint repair, Body panel repair.
