Vehicle Detail Report

Hyundai Lafesta 2021 280TGDi DCT Luxury Sport Dynamic Enjoyment edition

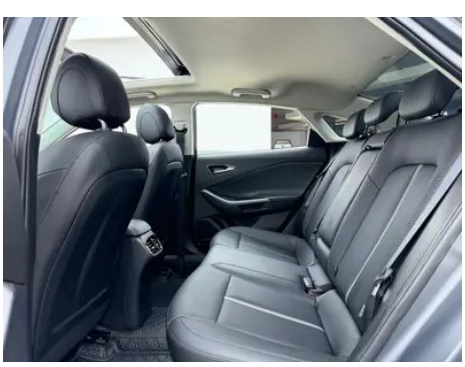
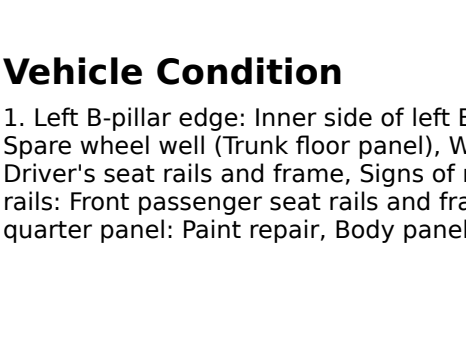
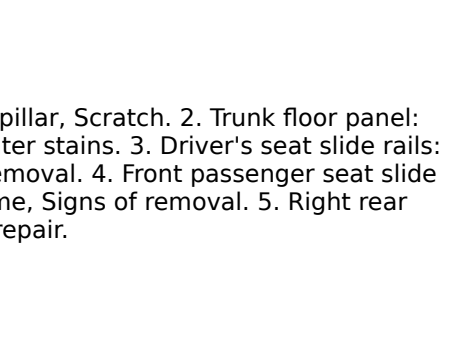
1. Left B-pillar edge: Inner side of left B-pillar, Scratch. 2. Trunk floor panel: Spare wheel well (Trunk floor panel), Water stains. 3. Driver's seat slide rails: Driver's seat rails and frame, Signs of removal. 4. Front passenger seat slide rails: Front passenger seat rails and frame, Signs of removal. 5. Right rear quarter panel: Paint repair, Body panel repair.
