Vehicle Detail Report

Honda Avancier 2020 240 TURBO CVT Smart Edition

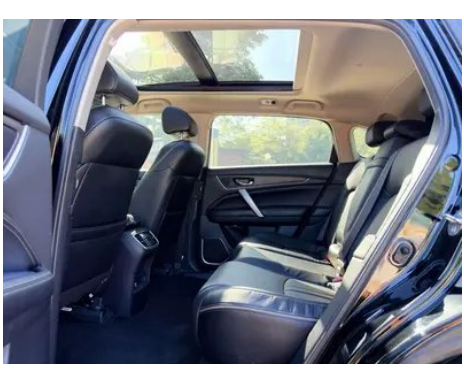
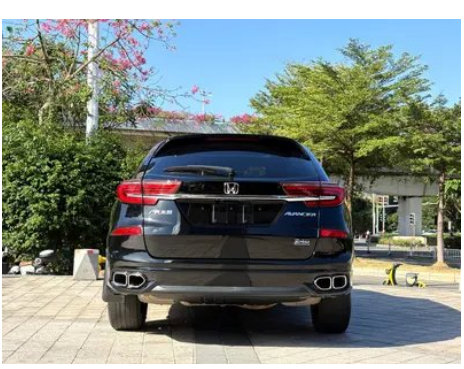
1. Headliner, Soiling. 2. Hood, Hood, Deformation. 3. Front bumper, Paint repair, Scrape, Scratch damage, Damage, Signs of removal. 4. Rear bumper, Deformation, Scrape, Scratch damage. 5. Left front door, Paint chip, Scrape, Deformation, Paint repair. 6. Right front door, Paint chip, Paint repair, Scrape, Scratch, Scratch damage. 7. Left rear door, Paint chip, Scrape, Scratch. 8. Right rear door, Paint chip, Paint repair, Deformation, Scrape, Scratch. 9. Trunk lid, Trunk lid, Scratch. 10. Left front fender, Scrape, Scratch. 11. Right front fender, Paint chip, Deformation, Scrape, Scratch. 12. Left rear quarter panel, Scratch, Scrape. 13. Right rear quarter panel, Scrape, Deformation. 14. Windshield, Scratch. 15. Left front door glass, Scratch. 16. Right front door glass, Scratch. 17. Left rear door glass, Scratch. 18. Right rear door glass, Scratch. 19. Left tail light, Scratch. 20. Right tail light, Scratch. 21. Headliner, Soiling.
