Vehicle Detail Report

Changan CS85 COUPE 2019 1.5T Moving version

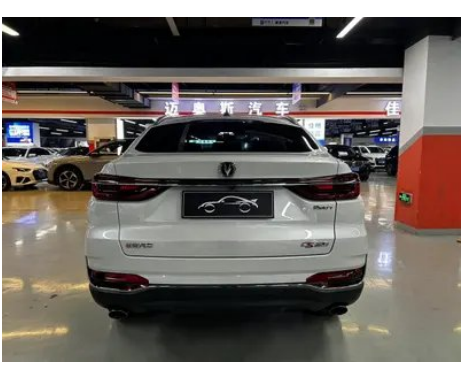
1. Right bottom edge beam, Right rocker panel, Outer-side deformation. 2. Headliner, Soiling. 3. Left rear quarter panel, Paint chip, Scratch. 4. Right rear quarter panel, Paint chip, Deformation. 5. Headliner, Soiling.
